**Flood Control Project Maintenance
Levee Inspections**

Maintenance Issue Types Only, Levee Inspection Report By Mile - Spring 2017

Reclamation District No. 0563 Tyler Island

Waterway	Bank	Unit Miles	Inspection Start/End	Inspector
Unit No. 01 Georgiana Slough (Tyler Island)	Left	12.11	03/14/2017 03/16/2017	Richard Willoughby

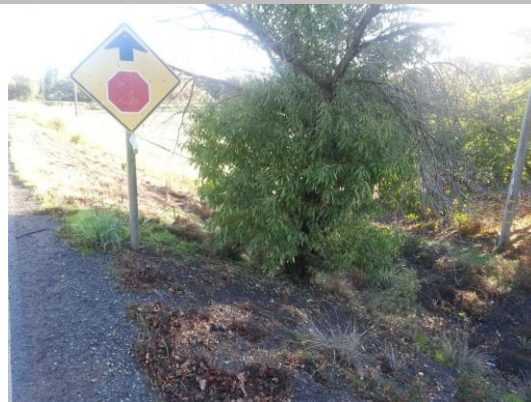
Photo 1 of 1 : SP_2017_RD0563_210_59_20170313_00047.jpg

Looking north at untrimmed tree on landward slope.

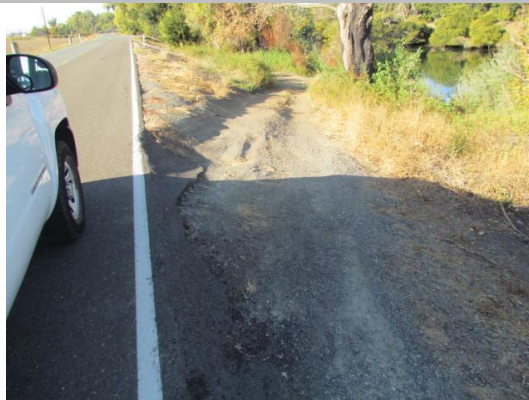
Photo 1 of 1 : SP_2017_RD0563_210_16_20170313_00016.jpg

LM Start	0.39	Rating **	M	Issue No.	16
LM End	0.39	Issue Type +	Ma	Location *	WS
Category	Earthen Levee			GPS Latitude/Longitude	
				Start	End
Item	Slope Stability			38.230841 °	38.230841 °
				-121.521898 °	-121.521898 °
DWR ID	DWR_RD0563_01_f_2013_16				
Comment Code					
S3 : Repair the levee slope damaged by vehicle traffic and prevent access where possible.					
Inspector Comment					
Slope damage is due to fishermen vehicle traffic.

Looking southwest at slope damage caused by vehicle traffic.

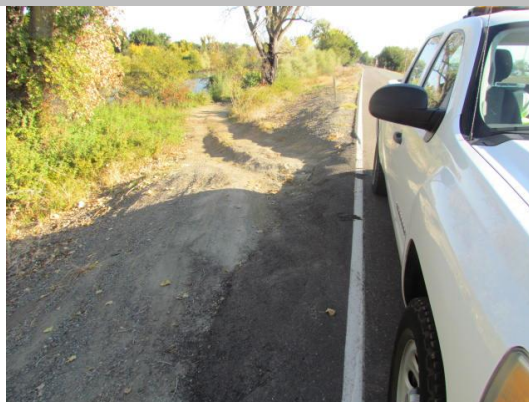
Photo 1 of 1 : SP_2017_RD0563_210_26_20170313_00022.jpg

LM Start	0.43	Rating **	M	Issue No.	26
LM End	0.43	Issue Type +	Ma	Location *	WS
Category	Earthen Levee			GPS Latitude/Longitude	
				Start	End
Item	Slope Stability			38.230460 °	38.230460 °
				-121.522324 °	-121.522324 °
DWR ID	DWR_RD0563_01_f_2013_26				
Comment Code					
S3 : Repair the levee slope damaged by vehicle traffic and prevent access where possible.					
Inspector Comment					
Slope damage due to fishermen vehicle traffic.

Looking northwest at slope damage caused by vehicle traffic.

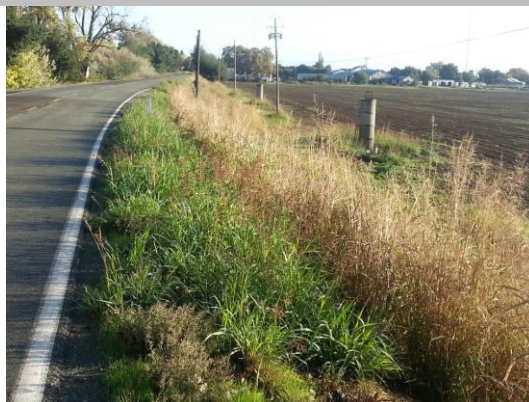
Photo 2 of 2 : SP_2017_RD0563_210_138_20170313_00114.jpg

LM Start	0.49	Rating **	A/W	Issue No.	138
LM End	0.65	Issue Type +	Ma	Location *	LS
Category	Earthen Levee			GPS Latitude/Longitude	
				Start	End
Item	Vegetation			38.229787 °	38.228094 °
				-121.523001 °	-121.525188 °
DWR ID	DWR_RD0563_01_f_2015_138				
Comment Code					
V2 : Remove the wild growth other than native grasses from the levee slopes.					
Inspector Comment					
Dense johnson grasses on landward slope.

Looking east at dense veg on landward slope.

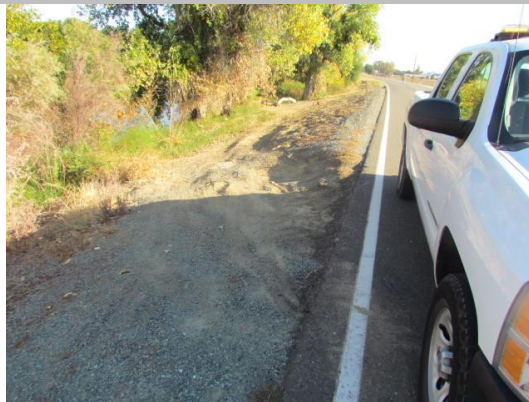
Photo 1 of 1 : SP_2017_RD0563_210_34_20170313_00029.jpg

LM Start	0.56	Rating **	M	Issue No.	34
LM End	0.56	Issue Type +	Ma	Location *	WS
Category	Earthen Levee			GPS Latitude/Longitude	
				Start	End
Item	Slope Stability			38.228948 °	38.228948 °
				-121.523904 °	-121.523904 °
DWR ID	DWR_RD0563_01_f_2013_34				
Comment Code					
S3 : Repair the levee slope damaged by vehicle traffic and prevent access where possible.					
Inspector Comment					
Slope damage is due to fishermen vehicle traffic.

Looking northwest at slope damage caused by vehicle traffic.

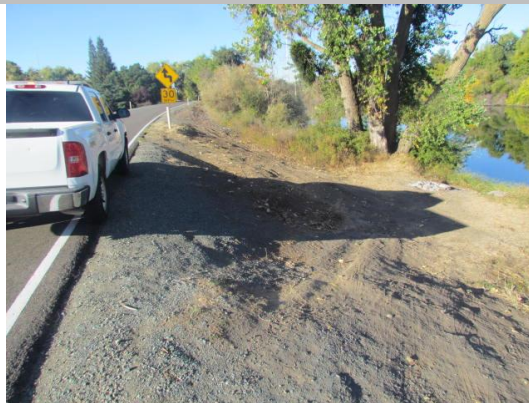
Photo 1 of 2 : SP_2017_RD0563_210_143_20170313_00127.jpg

LM Start	0.61	Rating **	M	Issue No.	143
LM End	0.61	Issue Type +	Ma	Location *	WS
Category	Earthen Levee			GPS Latitude/Longitude	
				Start	End
Item	Slope Stability			38.228507 °	38.228507 °
				-121.524543 °	-121.524543 °
DWR ID	DWR_RD0563_01_f_2014_143				
Comment Code					
S3 : Repair the levee slope damaged by vehicle traffic and prevent access where possible.					
Inspector Comment					
Slope damage due to vehicle traffic.

Looking southeast at slope damage on waterward slope.

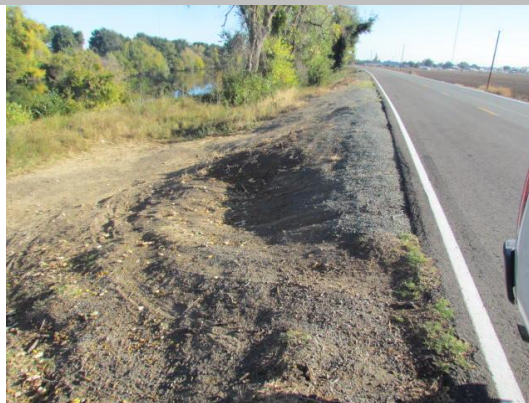
Photo 2 of 2 : SP_2017_RD0563_210_143_20170313_00128.jpg

Looking northwest at slope damage on waterward slope.

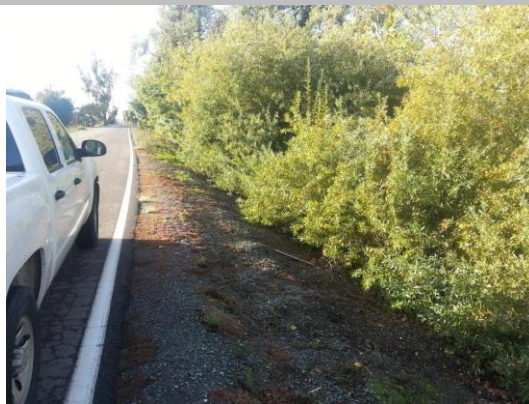
Photo 1 of 2 : SP_2017_RD0563_210_3_20170313_00001.jpg

Looking east at untrimmed trees on waterward slope. (Fall 2016)

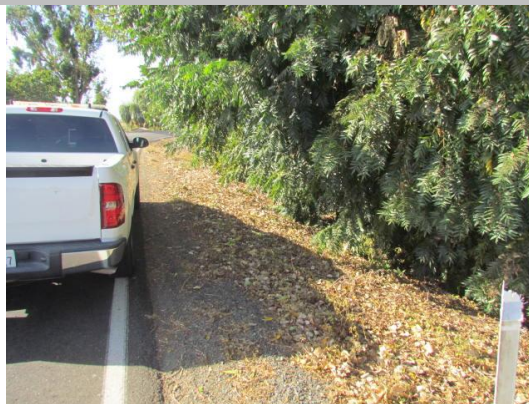
Photo 2 of 2 : SP_2017_RD0563_210_3_20170313_00002.jpg

Looking east at untrimmed trees on waterward slope and toe. (Spring 2016)

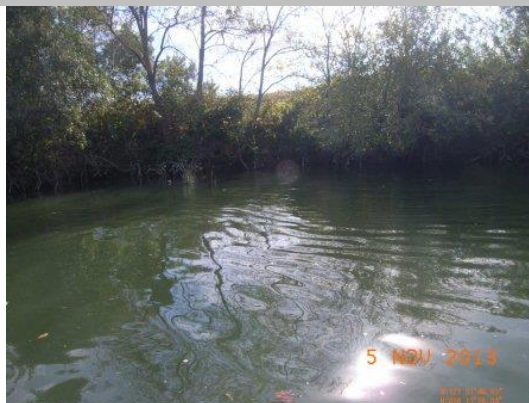
Photo 1 of 1 : SP_2017_RD0563_210_48_20170313_00041.jpg

LM Start	1.02	Rating **	M	Issue No.	48
LM End	1.11	Issue Type +	Ma	Location *	WS
Category	Supplemental			GPS Latitude/Longitude	
				Start	End
Item	2015 USACE Erosion Survey, DRAFT			38.226522 °	38.227157 °
				-121.529094 °	-121.530432 °
DWR ID	DWR_RD0563_01_s_2016_48				
Comment Code					
Inspector Comment					
2011 - Short sections of eroding bank at the waterline and holes in toe of levee. 2012 - Site extended upstream. 2013 - Erosion pockets filled with an insufficient amounts of revetment. 2015: Last observed in 2013. [2015 Site ID: GEO_11-0_L]

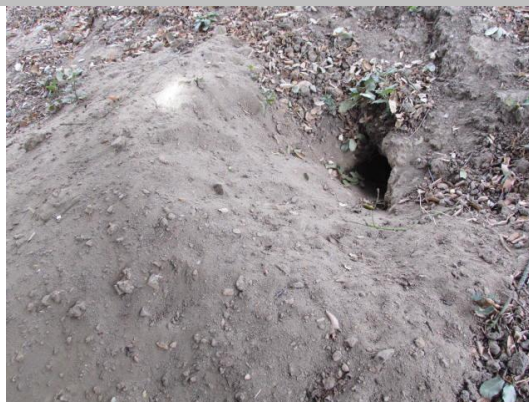
Photo 1 of 1 : SP_2017_RD0563_210_153_20170313_00134.jpg

LM Start	1.15	Rating **	U	Issue No.	153
LM End	1.15	Issue Type +	Ma	Location *	LS
Category	Earthen Levee			GPS Latitude/Longitude	
				Start	End
Item	Animal Control			38.226910 °	38.226910 °
				-121.531294 °	-121.531294 °
DWR ID	DWR_RD0563_01_f_2015_153				
Comment Code					
A3 : No rodents visible, but rodent burrows visible; need to backfill and compact or grout burrows.					
Inspector Comment					
Several large to medium rodent holes noted.

Looking at typical view of several rodent holes on landward slope.

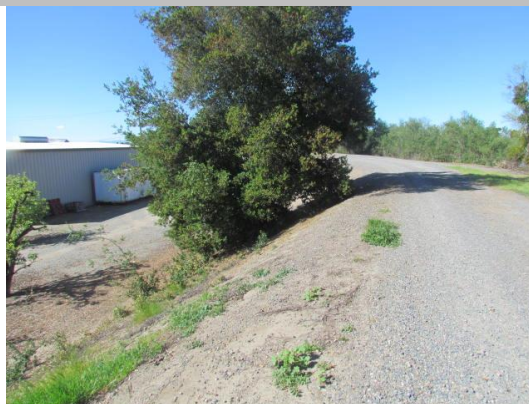
Photo 1 of 1 : SP_2017_RD0563_210_140_20170313_00120.jpg

Looking southeast at untrimmed tree at landward toe.

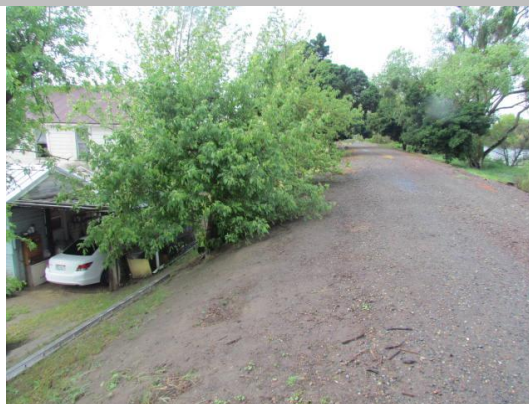
Photo 1 of 1 : SP_2017_RD0563_210_5_20170313_00003.jpg

LM Start	1.22	Rating **	M	Issue No.	5
LM End	1.22	Issue Type +	Ma	Location *	LS
Category	Earthen Levee			GPS Latitude/Longitude	
				Start	End
Item	Trim / Thin Trees			38.226326 °	38.226326 °
				-121.532298 °	-121.532298 °
DWR ID	DWR_RD0563_01_s_2012_5				
Comment Code					
T1 : Trim trees to at least five feet above ground level.					
Inspector Comment

Looking south at untrimmed trees on landward slope.

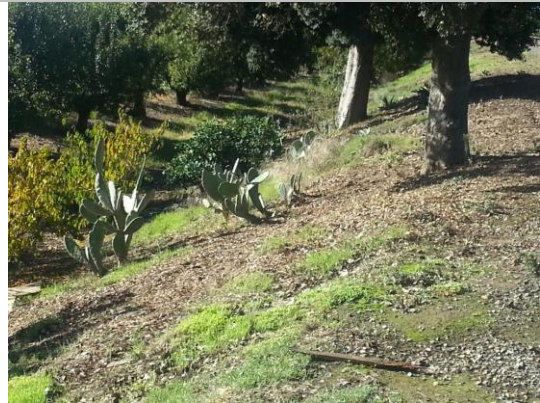
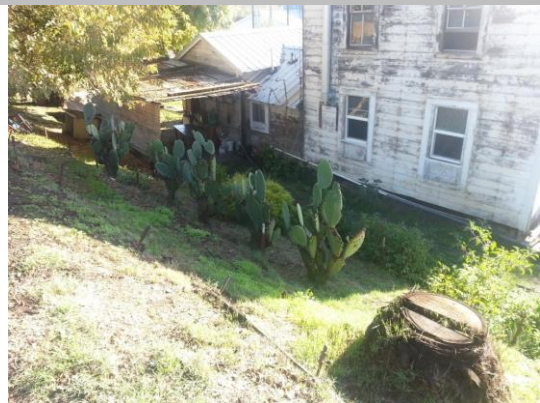
Looking southeast at cactus on landward slope.

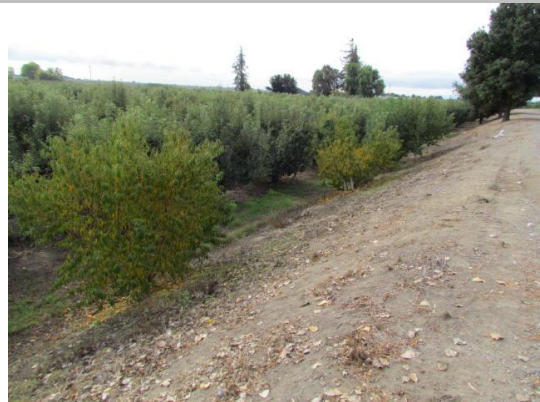
Photo 1 of 1 : SP_2017_RD0563_210_64_20170313_00050.jpg

LM Start	1.27	Rating **	M	Issue No.	64
LM End	1.27	Issue Type +	Ma	Location *	LS
Category	Earthen Levee			GPS Latitude/Longitude	
				Start	End
Item	Trim / Thin Trees			38.225730 °	38.225730 °
				-121.532824 °	-121.532824 °
DWR ID	DWR_RD0563_01_f_2012_64				
Comment Code					
T1 : Trim trees to at least five feet above ground level.					
Inspector Comment					
Trees located at landside toe.

Looking southeast at fruit trees on landside toe.

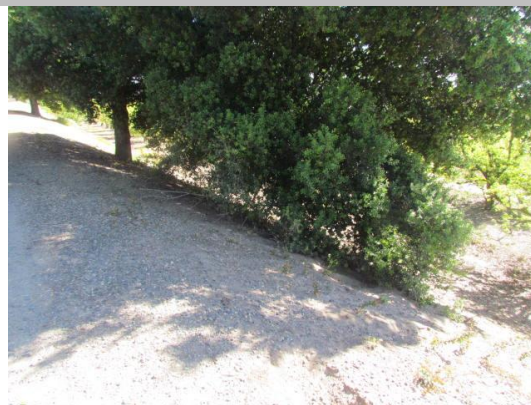
Photo 1 of 1 : SP_2017_RD0563_210_79_20170313_00077.jpg

Looking northeast at untrimmed trees on landward slope and toe.

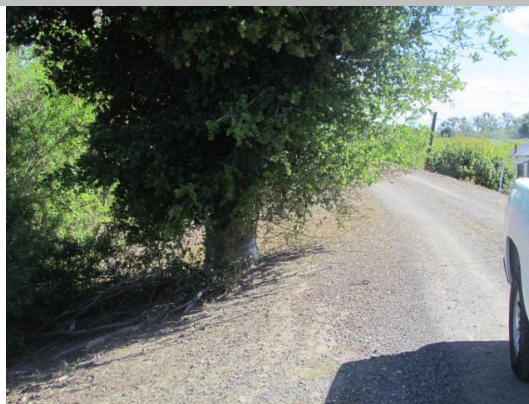
Photo 1 of 1 : SP_2017_RD0563_210_759_20170313_00147.jpg

Looking northwest at untrimmed trees on waterward slope and toe.

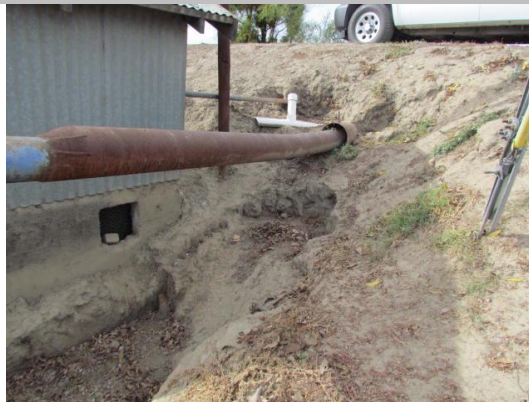
Photo 1 of 2 : SP_2017_RD0563_210_71_20170313_00055.jpg

Looking west at erosion at landside toe and slope next to pump house.

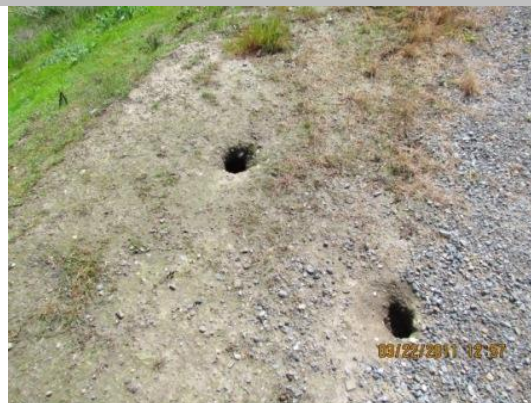
Photo 1 of 1 : SP_2017_RD0563_210_33_20170313_00028.jpg

Looking southeast at squirrel holes on landside shoulder.

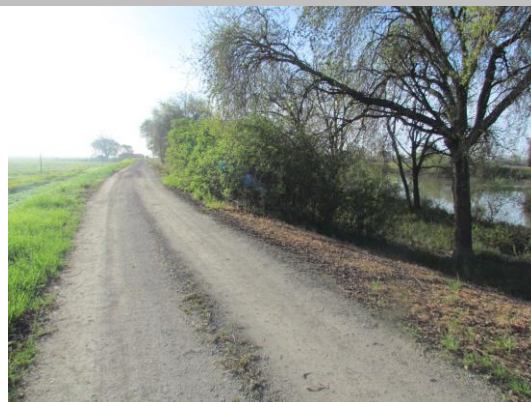
Photo 1 of 3 : SP_2017_RD0563_210_12_20170316_00245.jpg

Looking southwest at dense elderberries on waterward shoulder and slope. (Spring 2017)

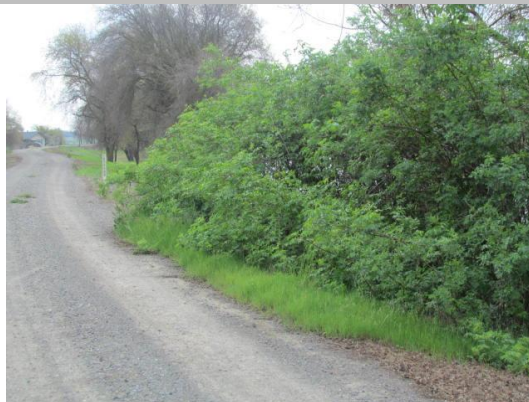
Photo 3 of 3 : SP_2017_RD0563_210_12_20170313_00013.jpg

Looking southwest at dense elderberry on waterside shoulder and slope.
(Fall 2014)

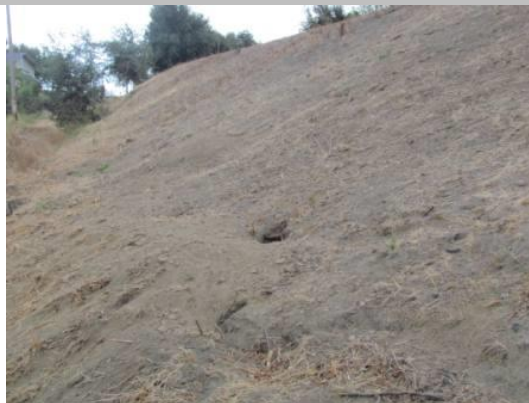
Photo 3 of 4 : SP_2017_RD0563_210_85_20170313_00083.jpg

Looking southwest at rodent holes on landside slope.

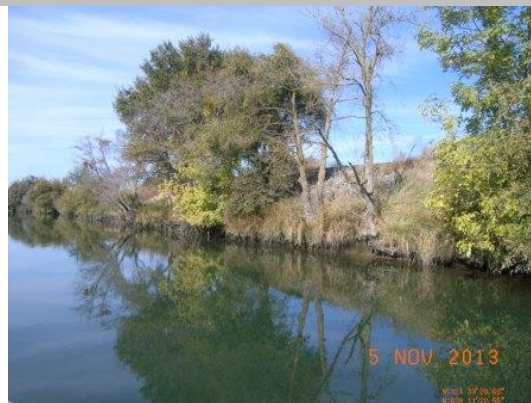
Photo 1 of 1 : SP_2017_RD0563_210_39_20170313_00032.jpg

LM Start	2.61	Rating **	M	Issue No.	39
LM End	2.82	Issue Type +	Ma	Location *	WS
Category	Supplemental			GPS Latitude/Longitude	
				Start	End
Item	2015 USACE Erosion Survey, DRAFT			38.214133 °	38.211737 °
				-121.537778 °	-121.535436 °
DWR ID	DWR_RD0563_01_s_2016_39				
Comment Code					
Inspector Comment					
1997 - Loss of rock at toe; pockets of upper berm erosion; very narrow berm width; toe rock problem; erosion pockets in rock. 2002 - New brush boxes at toe of the worst spots. 2005 - Upstream 200 ft removed because of the wide berm. 2006 - Some rock repair pockets behind the brush boxes at the upstream end. 2010 - Some new erosion. 2013 - New rock placed on the levee slope. 2015: Last observed in 2013. [2015 Site ID: GEO_9-3_L]

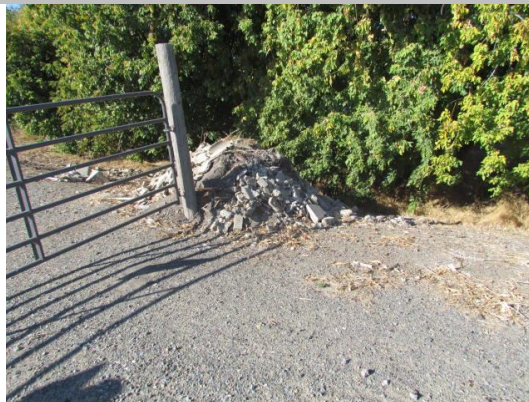
Photo 1 of 2 : SP_2017_RD0563_210_104_20170313_00105.jpg

LM Start	2.89	Rating **	M	Issue No.	104
LM End	2.89	Issue Type +	Ma	Location *	LS
Category	Earthen Levee			GPS Latitude/Longitude	
				Start	End
Item	Encroachments			38.210966 °	38.210966 °
				-121.534813 °	-121.534813 °
DWR ID	DWR_RD0563_01_f_2013_104				
Comment Code					
MA : Material					
Inspector Comment					
Landowner stockpiled concrete rubble on landward and waterward slope to stop trespassers. Landowner should replace the stockpile with a proper fence.

Looking west at concrete rubble on waterward shoulder and slope.

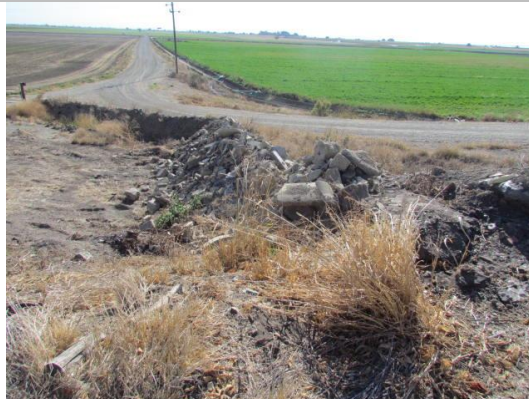
Photo 2 of 2 : SP_2017_RD0563_210_104_20170313_00106.jpg

Looking east at concrete rubble on landward slope.

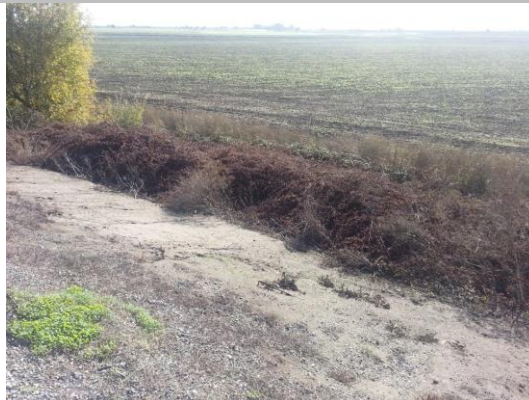
Photo 2 of 2 : SP_2017_RD0563_210_67_20170313_00051.jpg

Looking east at dead berryvines at landward toe. (Fall 2016)

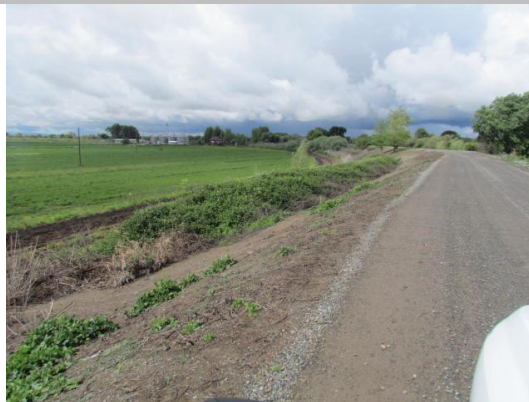
Photo 3 of 3 : SP_2017_RD0563_210_74_20170313_00060.jpg

Looking southeast at dense berryvines at landward toe. (Spring 2015)

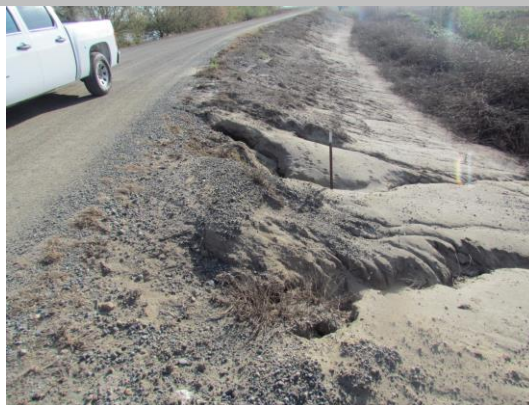
Photo 1 of 4 : SP_2017_RD0563_210_78_20170316_00251.jpg

Looking north at rain runoff erosion on landward slope. (Spring 2017)

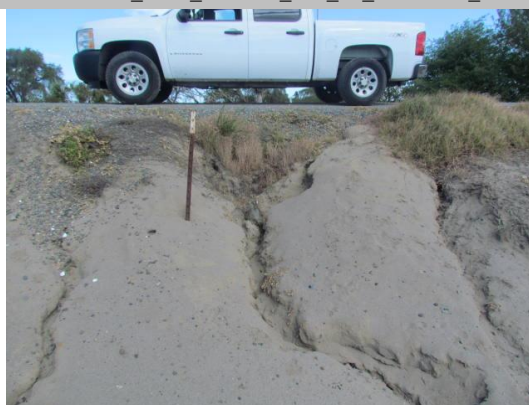
Photo 2 of 4 : SP_2017_RD0563_210_78_20170313_00072.jpg

Looking west at rain runoff erosion on landward slope. (Spring 2016)

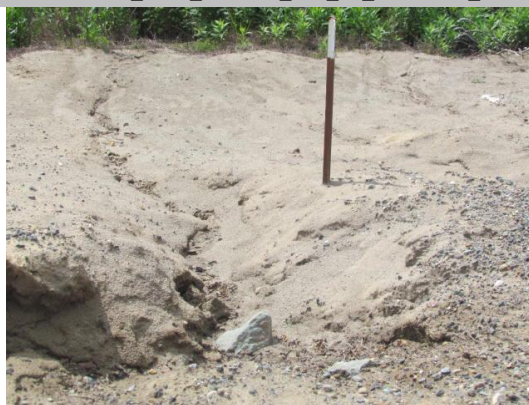
Photo 3 of 4 : SP_2017_RD0563_210_78_20170313_00075.jpg

Looking east at slope erosion. (Updated Spring 2012)

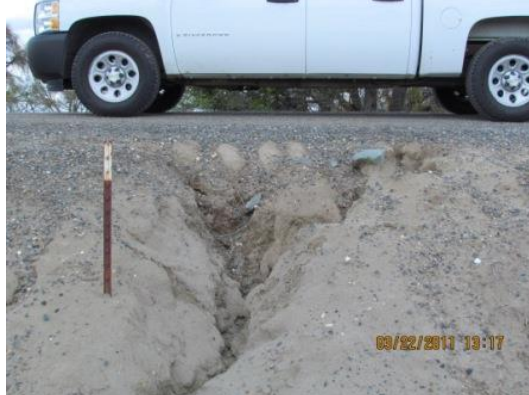
Photo 4 of 4 : SP_2017_RD0563_210_78_20170313_00076.jpg

Looking west at slope erosion cause by runoff on landside slope.

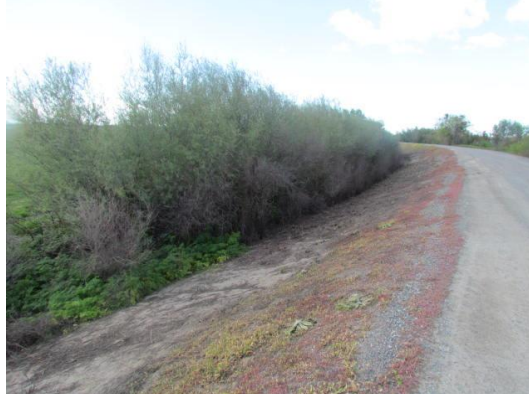
Photo 1 of 2 : SP_2017_RD0563_210_763_20170313_00149.jpg

Looking south at dense vegetation (willows) at landward toe. (Spring 2016)

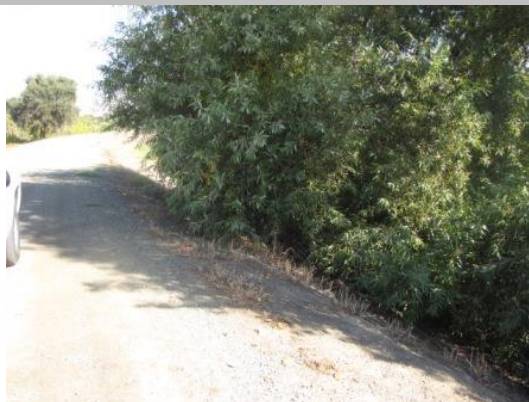
Photo 2 of 2 : SP_2017_RD0563_210_68_20170313_00054.jpg

Looking southeast at dense trees on landside slope and toe.

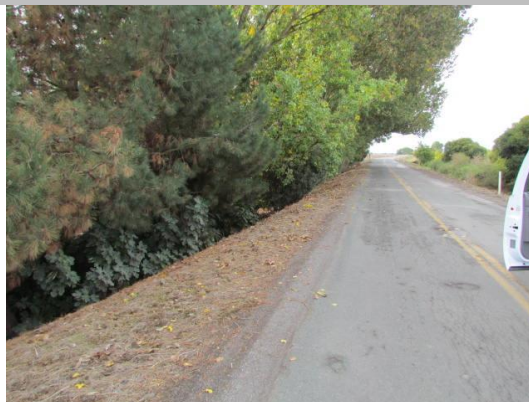
Photo 1 of 1 : SP_2017_RD0563_210_88_20170313_00086.jpg

Looking south at dense trees on landside slope and toe.

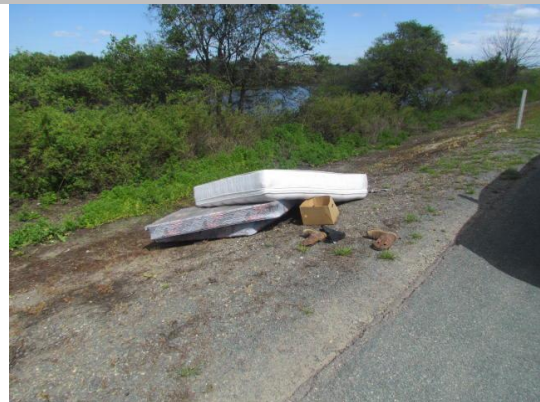
Photo 1 of 1 : SP_2017_RD0563_210_163_20170313_00137.jpg

Looking west at garbage on waterward slope.

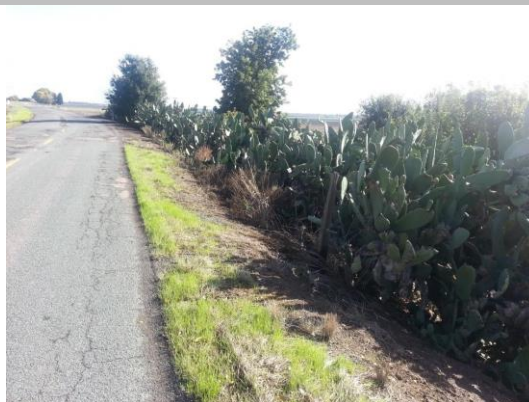
Photo 2 of 2 : SP_2017_RD0563_210_22_20170313_00019.jpg

Looking downstream at dense cactus on landward slope. (Fall 2016)

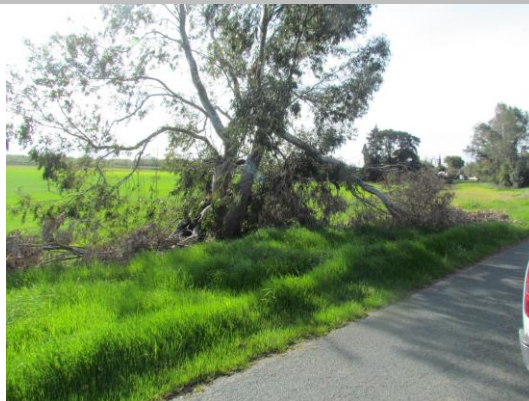
Photo 1 of 1 : SP_2017_RD0563_210_128_20170316_00258.jpg

Looking east at broken tree limbs on landward slope.

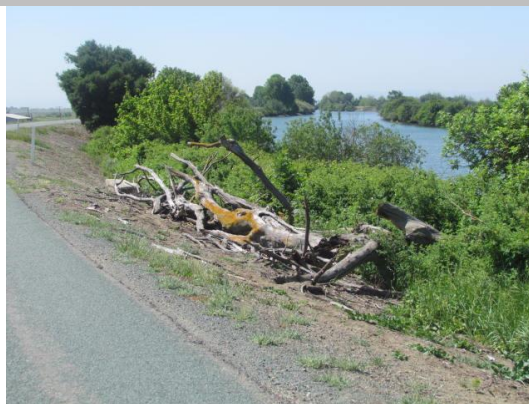
Photo 1 of 1 : SP_2017_RD0563_210_95_20170313_00096.jpg

Looking southwest at prunings on waterward slope.

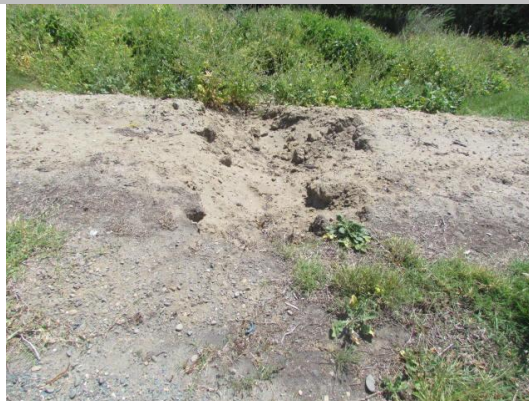
Photo 1 of 1 : SP_2017_RD0563_210_97_20170313_00098.jpg

Looking east at slope erosion on landward shoulder and slope.

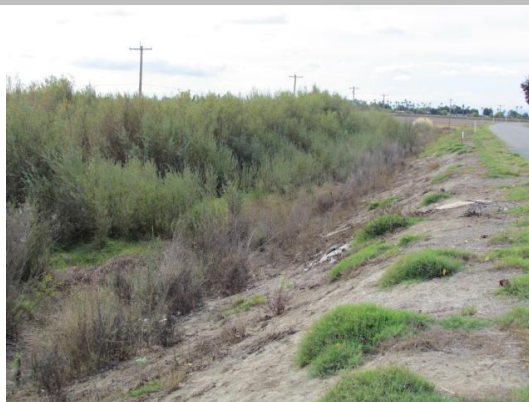
Photo 3 of 5 : SP_2017_RD0563_210_90_20170313_00089.jpg

Looking south at dense vegetation on landside toe. (2012 Fall Inspection)

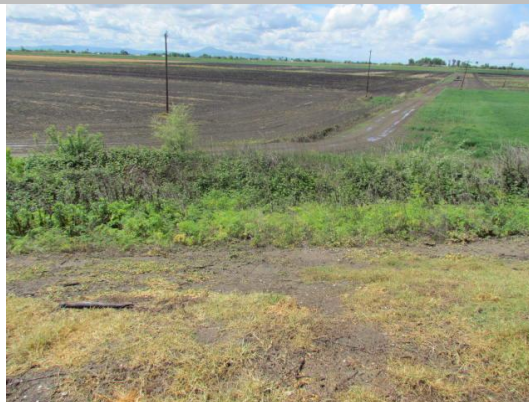
Photo 1 of 1 : SP_2017_RD0563_210_769_20170313_00153.jpg

Looking east at dense vegetation at landward toe. (Spring 2015)

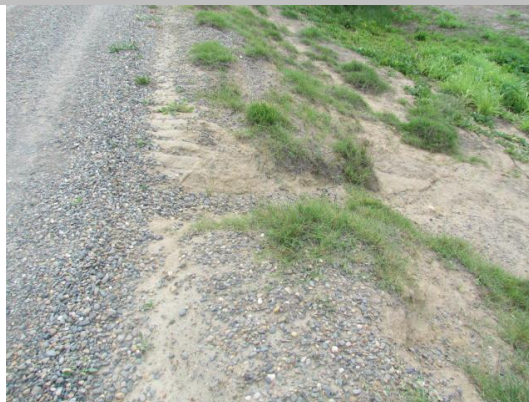
Photo 2 of 2 : SP_2017_RD0563_210_99_20170313_00101.jpg

Looking north at minor erosion on landward shoulder and slope.

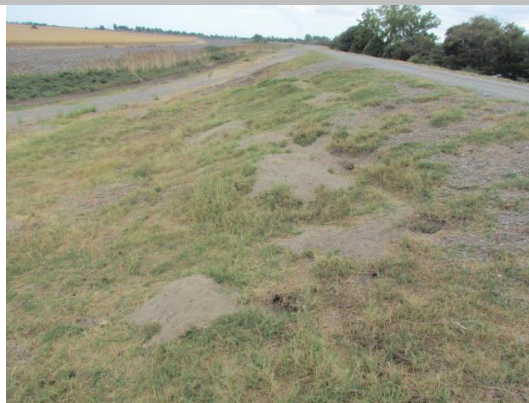
Photo 3 of 5 : SP_2017_RD0563_210_77_20170313_00070.jpg

Looking south at several rodent holes on landward slope.

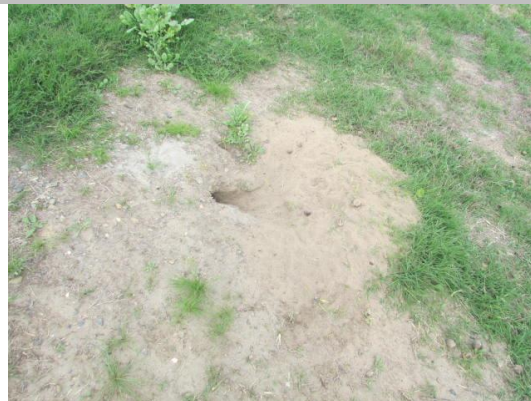
Photo 4 of 5 : SP_2017_RD0563_210_77_20170313_00071.jpg

Looking at typical rodent holes on landward slope.

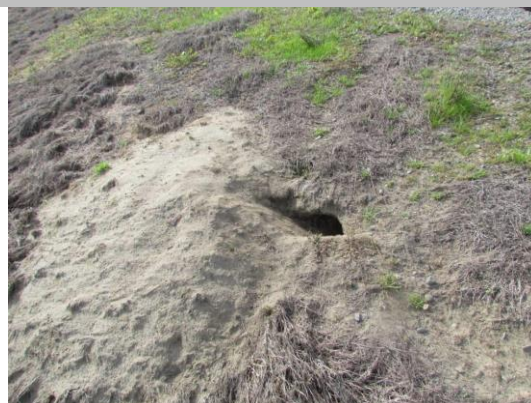
Photo 5 of 5 : SP_2017_RD0563_210_77_20170316_00261.jpg

Looking at typical rodent hole along this reach. (Spring 2017)

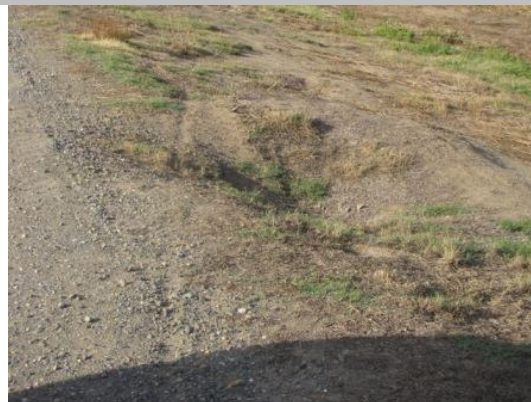
Photo 1 of 4 : SP_2017_RD0563_210_76_20170313_00064.jpg

Looking northeast a depression on landside shoulder and slope above 10" irrigation pipe four feet below crown.

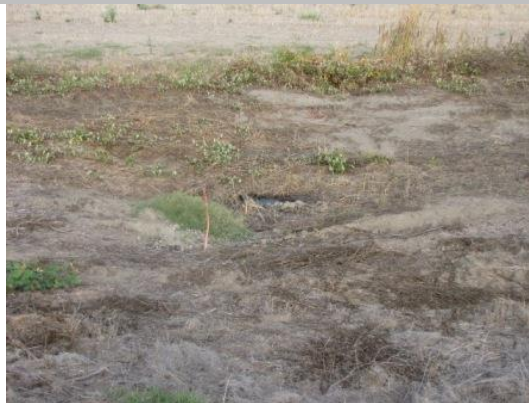
Photo 2 of 4 : SP_2017_RD0563_210_76_20170313_00065.jpg

Looking east at water ponding at landside toe just above 10" irrigation pipe.

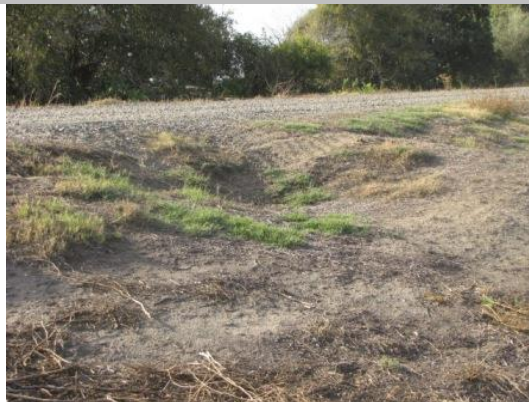
Photo 4 of 4 : SP_2017_RD0563_210_76_20170313_00067.jpg

Looking west at depression on landside shoulder and slope.

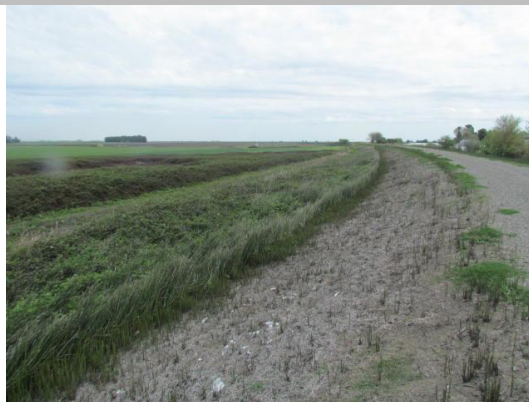
Photo 3 of 3 : SP_2017_RD0563_210_100_20170313_00104.jpg

Looking south at additional dense vegetation at landward toe.

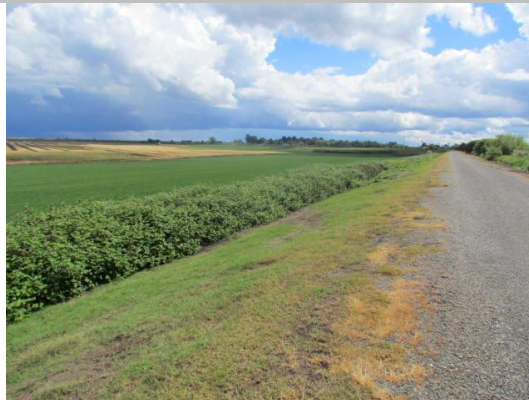
Photo 2 of 2 : SP_2017_RD0563_210_770_20170313_00154.jpg

Looking southeast at dense vegetation at landward toe. (Spring 2015)

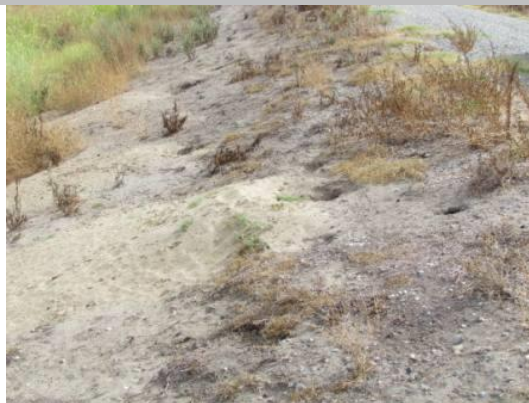
Photo 3 of 3 : SP_2017_RD0563_210_91_20170313_00094.jpg

Looking south at rodent holes on landside slope.

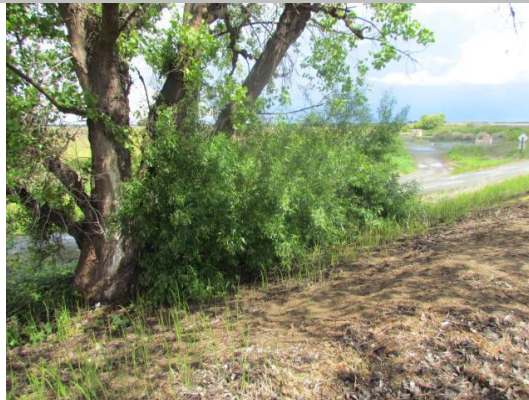
Photo 1 of 1 : SP_2017_RD0563_210_47_20170313_00040.jpg

Looking east at untrimmed tree at landward slope. (Spring 2015)
